LAC CATALINA DAM

MO 30286

ST. FRANCOIS COUNTY, MISSOURI

PHASE 1 INSPECTION REPORT NATIONAL DAM SAFETY INSPECTION

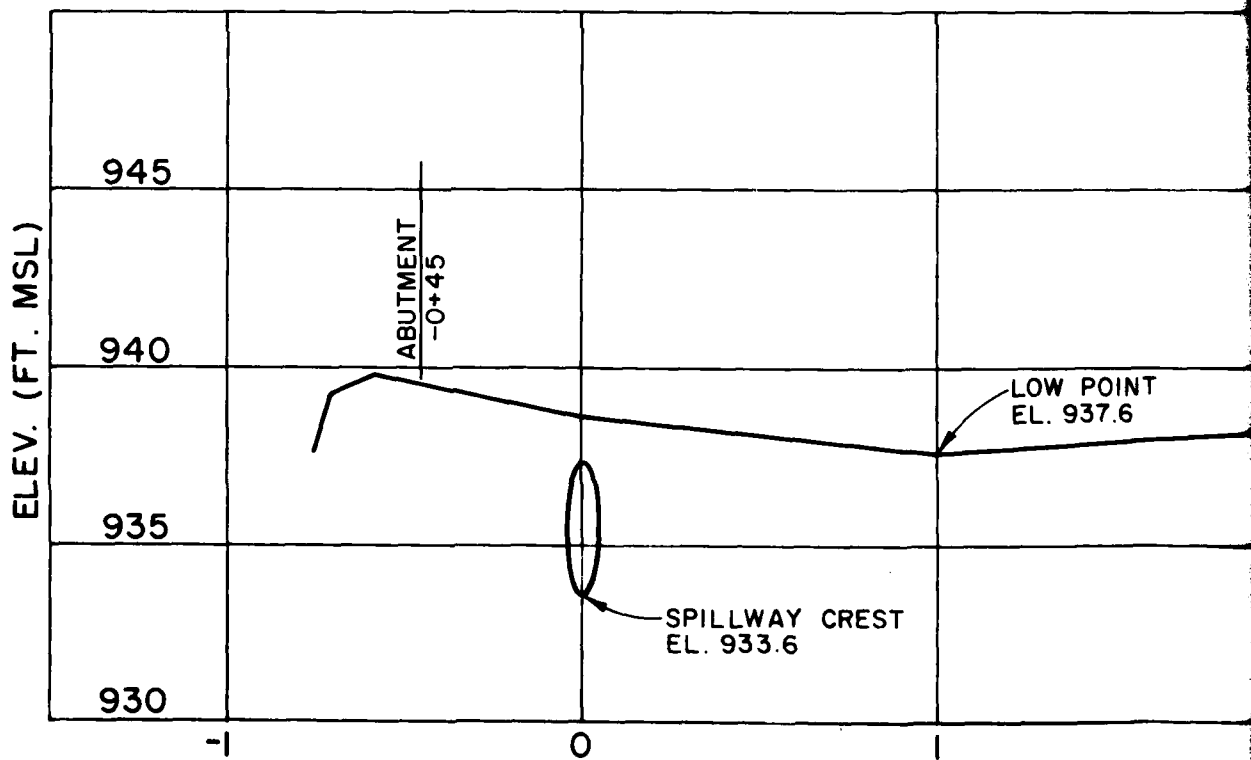
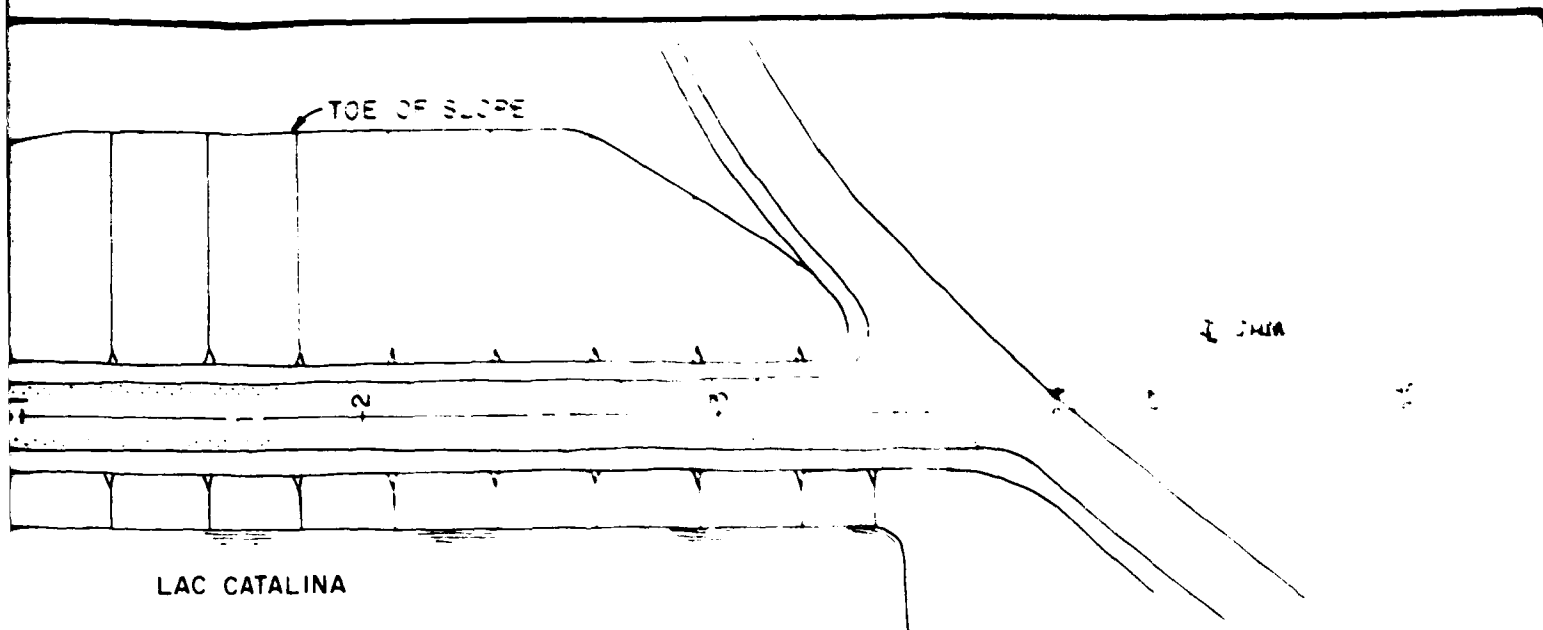
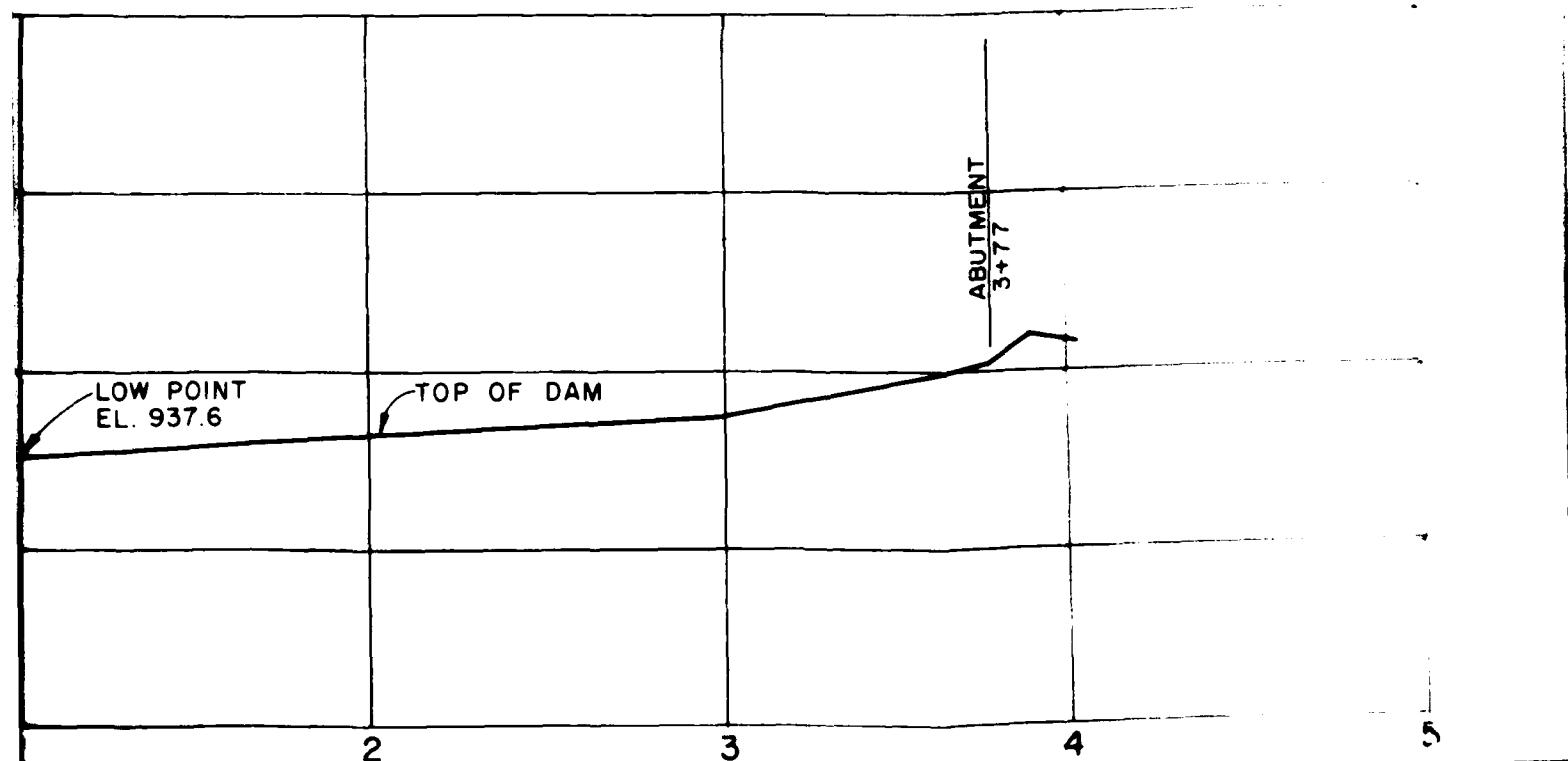
LAC CATALINA
 DAM PLAN & PROFILE

- b. Description of Dam and Appurtenances. The Lac Catalina Dam is an earthfill type embankment rising approximately 30 feet above the original stream bed. The embankment has an upstream slope (above the waterline) of 1v on 3.9h, a crest width of about 30 feet, and a downstream slope of about 1v on 2.2h. The length of the dam is approximately 422 feet and an unpaved road traverses the dam crest. A plan and profile of the dam are shown on Plate 5 and a cross-section of the dam is shown on Plate 6.
